**05/11/12 INSPECTION REPORT FOR:  
1336 W. 65TH AVE., PHILADLEPHIA, PA 19126**

TO: John Robinson  
RE: 1336 W. 65th Ave.,  
Philadelphia, PA 19126

At your request, a home inspection of the above property was performed on 05/11/12. **Armored Home Inspections, LLC** is pleased to submit the enclosed report. This report is a professional opinion based on a visual inspection of the accessible components of the building.

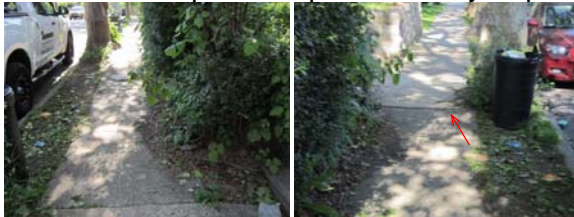
Uneven pavement may result in a hazard at front, pad leveling/replacement recommended. An estimate for repair or replacement by a qualified contractor is recommended.

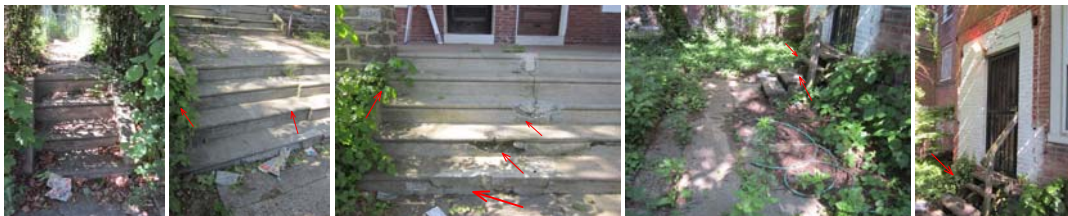
1. Railing missing at the three sets of front stairs. Railings are recommended when three or more risers are present in the stair construction.

2. Stair damage/deterioration noted at the front entry. Stair repairs recommended for occupant safety.

3. Damage wooden stair rise and run noted at the rear of the building. Stair repairs/replacement recommended.

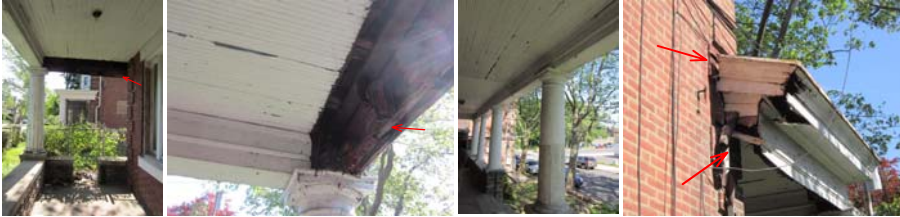
**Porch:** Concrete- 1.Damaged left end roof rake end and wood framing noted. Area repairs by a qualified contractor is advised.

2.Deferred wood trim and ceiling maintenance noted through out. Porch exterior maintenance and repairs recommended by qualified contractors.

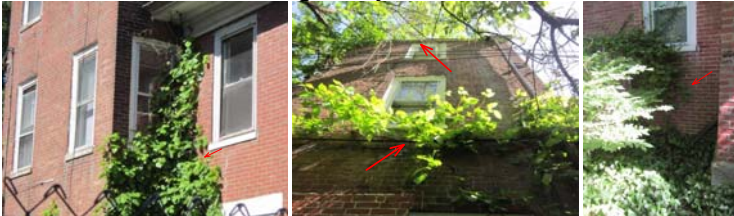
1.Overgrown vegetation noted around the structure and vine growth upon the structure. Cutting back vegetation away from the building and removing the vine growth from the building is recommended.

2. Tree limbs close to the structure and may be causing damage to the roof or structure at the rear. Tree limb trimming away from the structure 5'-10' recommended.

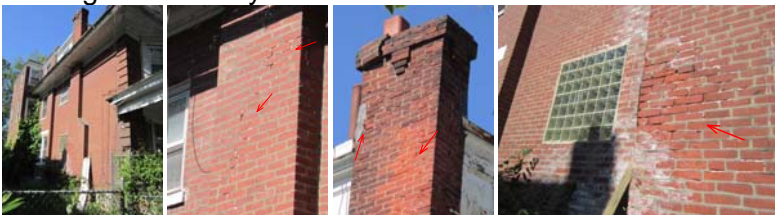
1. Mortar loss evident in exterior wall. Pointing/wall maintenance to prevent further mortar loss and possible water infiltration is recommended.

2.Overgrown vegetation limited wall visibility. Rating reflects the visible wall area. Cutting back the vegetation away from the exterior wall is advised.

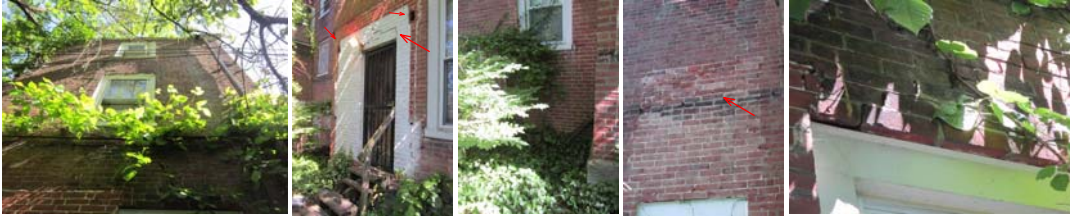
1. Stress cracks and mortar/brick loss noted. Sealing/repairs recommended to prevent water infiltration.

2. Overgrown vegetation limited wall visibility. Rating reflects the visible wall area. Cutting back the vegetation away from the exterior wall is advised.

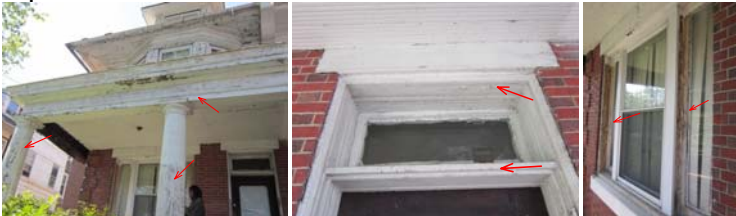
1. Wood trim at the front porch columns, wood beam cover, window trim, and entry door trim noted with significant peeling paint and deferred maintenance.

2. Left end of the porch with wood rot and significant damage. Area evaluation and a quote for repairs recommended.

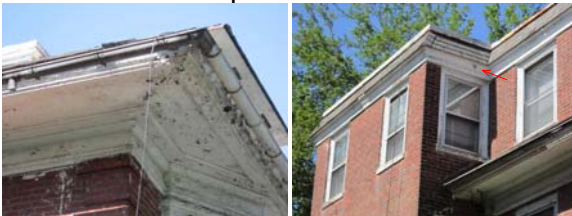
Peeling paint noted throughout the fascias. Fascia scraping and painting/maintenance recommended to prevent further deterioration.

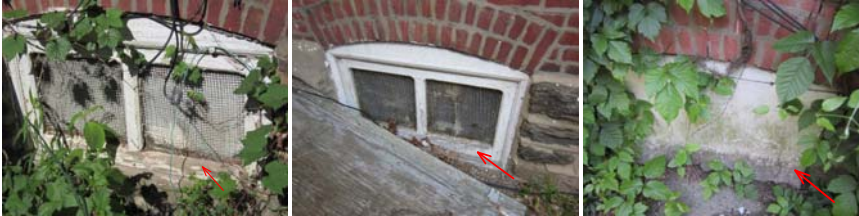
**Basement Windows:** Wood Hinge Units, Boarded- Only window screens were visible from the exterior. Deferred maintenance noted at the wood framed screens. Screen and trim maintenance to prevent wood decay is advised. Budgeting for window unit replacements advised.

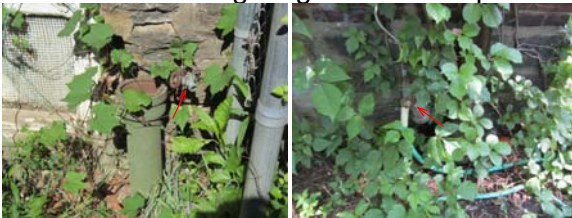
**Hose Bibs:** Faucet/Gate- Water supply was off to the dwelling. Therefore the faucet was only visually inspected. Older faucet noted. Budgeting for faucet replacement is advised.

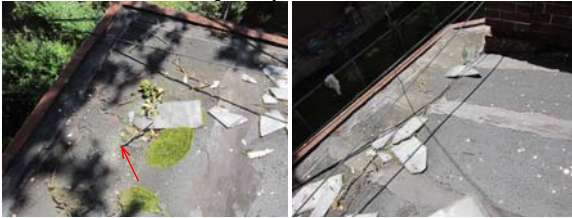
Roof shows signs of deterioration, roof evaluation and estimate for repair/replacement recommended by a qualified roofer.

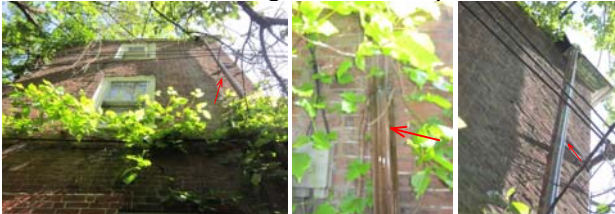
Corroded and leaking rear downspout noted. Unit replacement recommended.

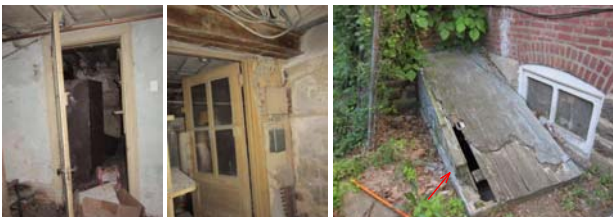
1. The interior door noted within the basement was not tested. Visual inspection revealed no deficiencies.

2. The walk out hatch door is deteriorated and in need of replacement.

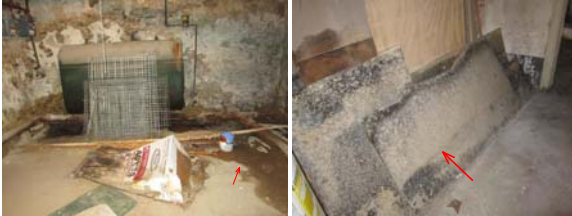
8. Defective **Moisture Location:** Present-  
1. Moisture at the front of the basement was observed. The uncovered waste piping with raw sewage in the area appears to have been the source of the moisture. However, storm water infiltration cannot be ruled out as a possible re-occurring condition.  
2. Stored items within the basement were also noted with significant mold growth. Removal of stored items in the basement and sewage clean up to prevent a health concern is advised.

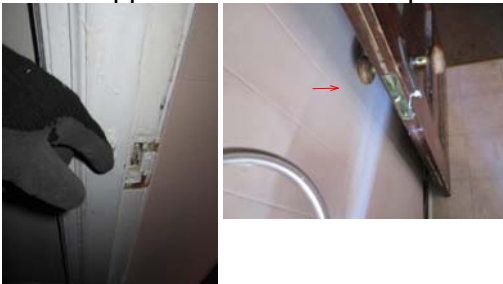
Door stopper recommended to prevent wall damage.

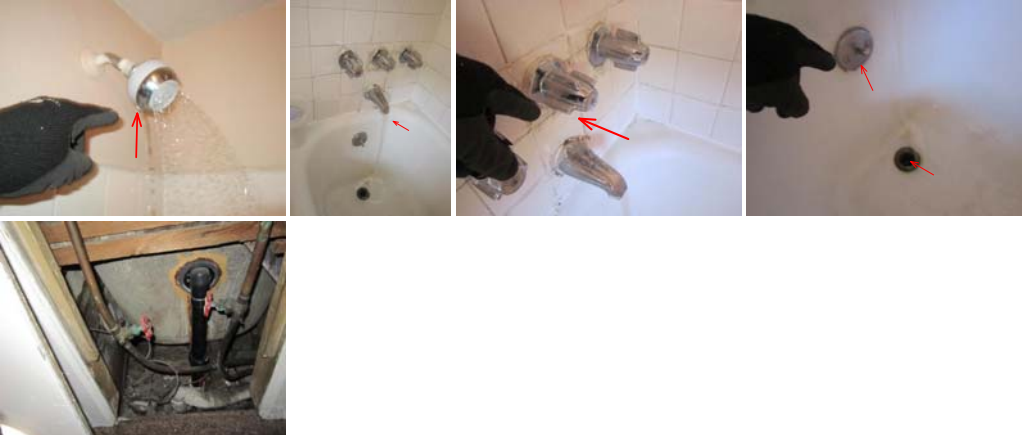
**Tub/Surround:** Fiberglass tub and ceramic tile surround-  
1. Shower head connection leaks when in use, plumber evaluation and repair advised.  
2. Diverter valve leaks when in use, plumber evaluation and repair advised.  
3. Stopper not functional. Plumber evaluation and repair recommended.

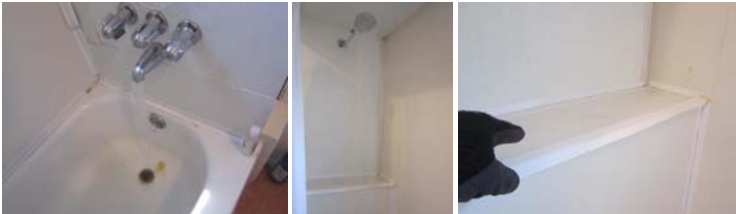
23. Marginal **Tub/Surround:** Porcelain/cast iron tub and plastic surround-  
Ledge in the shower area is subject to leaks. Consider an alternative to the ledge to prevent leaks advised.

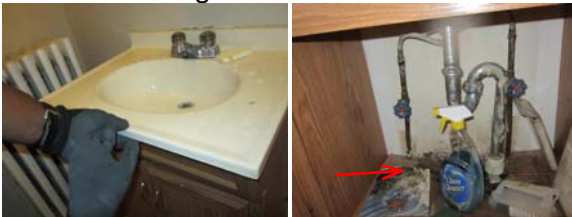
1. Counter top/sink not properly mounted to cabinet, securing recommended by a qualified professional.
2. Water damage noted at the base of the cabinet. Cabinet/vanity replacement recommended.

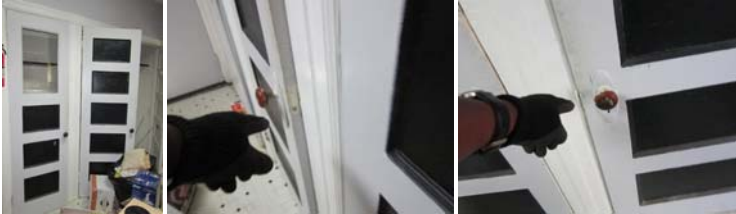
36. Marginal **Closets:** Pantry, Standard-  
Doors do not catch in the jamb. Door hardware adjustments recommended.

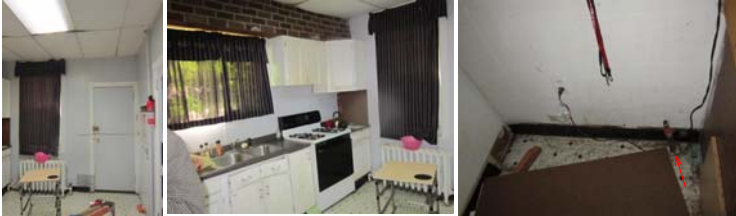
37. Marginal **Walls:** Painted wallboard-  
Proper plug for the unused gas line is advised.

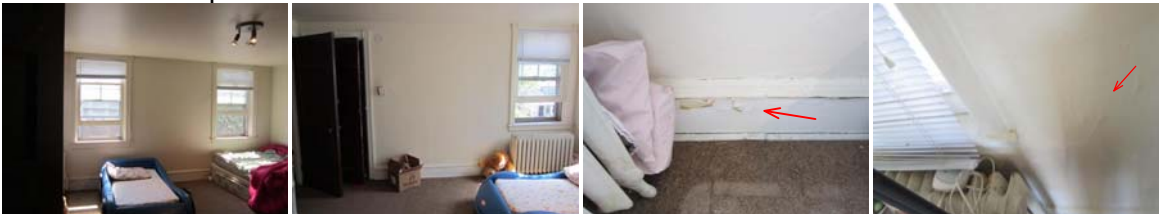
Evidence of past or present water penetration at the rear left wall. Exterior water intrusion control and cosmetic repairs recommended.

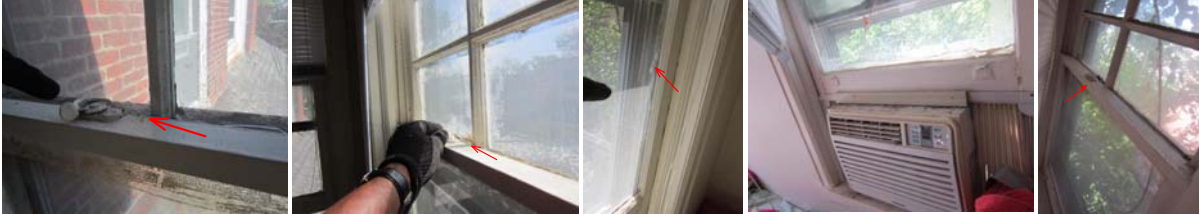
Windows couldn't lock and deteriorated glazing observed. Budgeting or widow repairs or replacement recommended.

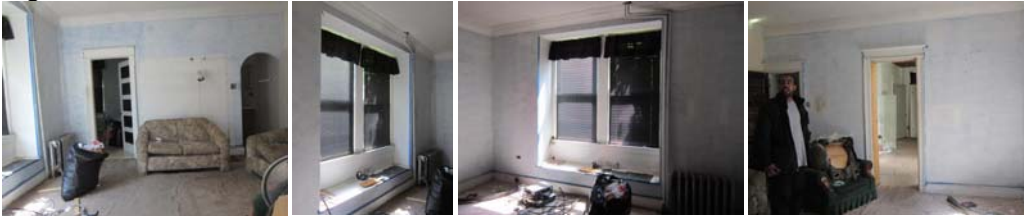
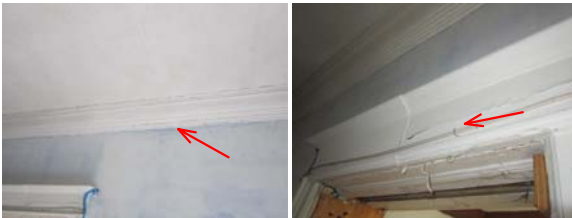
Evidence of previous leaks at the entry opening and peeling paint noted at the wood trim. Scraping and painting recommended. Paint may contain lead. Protection against ingestion/inhalation advised.

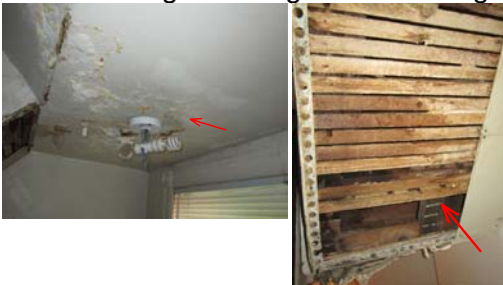
**Ceiling:** Painted wallboard/plaster-  
Water damaged ceiling noted. Ceiling repair/replacement needed.

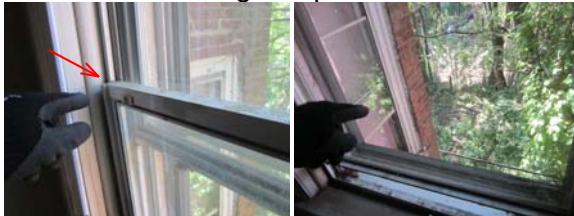
2. Screens missing. Replacement/re-installation prior to settlement advised.

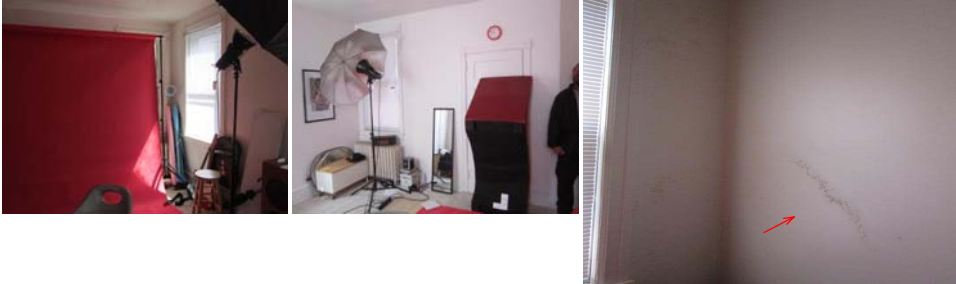
Evidence of past or present water penetration, exterior repairs/maintenance and cosmetic repairs recommended.

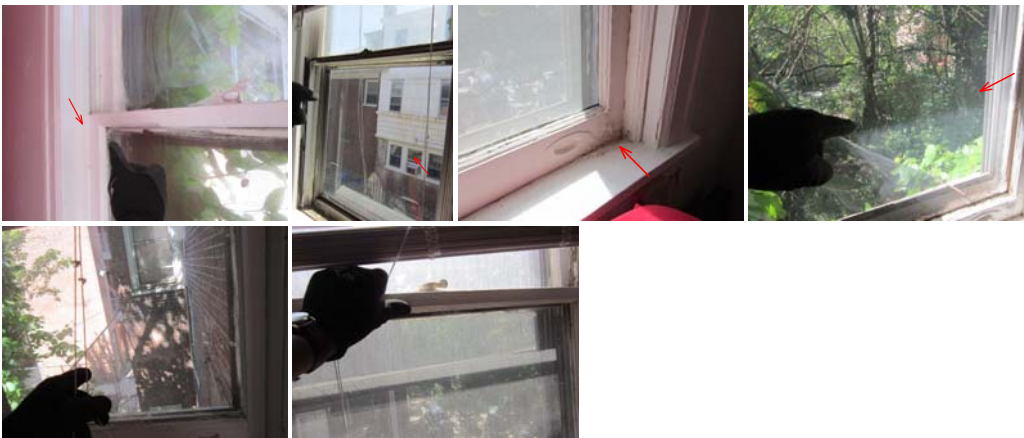
4. Evidence of water/moisture at the left rear unit. Water penetration control needed.

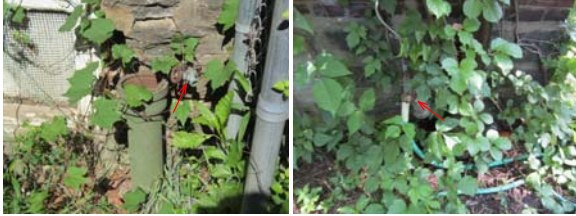
Water supply was off to the dwelling. Therefore the faucet was only visually inspected. Older faucet noted. Budgeting for faucet replacement is advised.

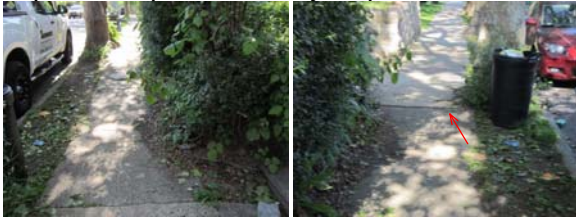
Uneven pavement may result in a hazard at front, pad leveling/replacement recommended. An estimate for repair or replacement by a qualified contractor is recommended.

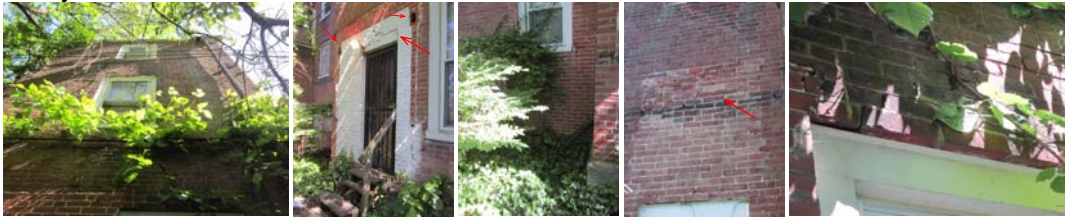
2. Overgrown vegetation limited wall visibility. Rating reflects the visible wall area. Cutting back the vegetation away from the exterior wall is advised.

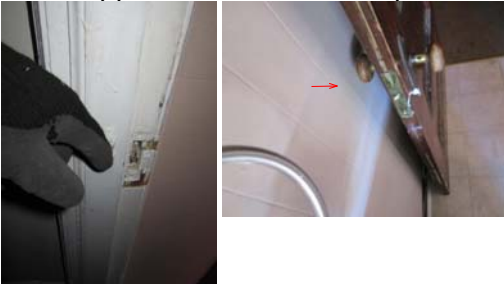
- 33. 3rd Floor Bathroom Doors:** Wood paneled door-  
Door stopper recommended to prevent wall damage.

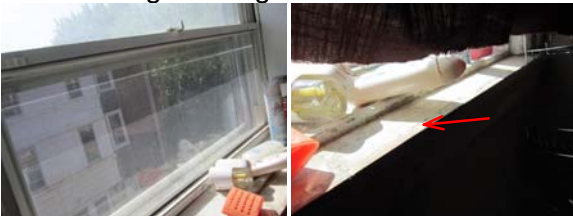
- 34. 3rd Floor Bathroom Windows:** Aluminum double hung-  
Peeling paint observed at the window sill. Scraping and painting recommended. Paint may contain lead.  
Protection against ingestion/inhalation advised.

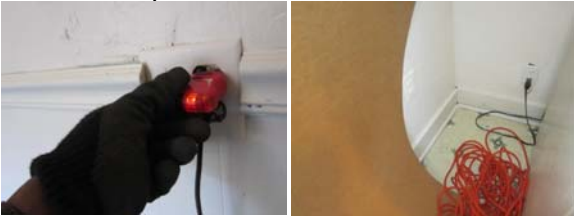
- 57. 2nd Floor Kitchen Electrical:** 110 VAC lighting circuit-  
A GFCI receptacle/circuit is recommended at receptacles within 6 feet of a water source.

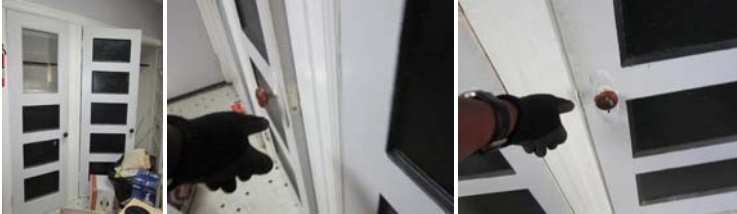
Doors do not catch in the jamb. Door hardware adjustments recommended.

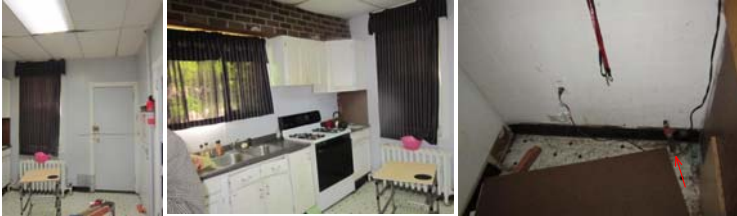
**63. 1st Floor Kitchen Walls:** Painted wallboard-

Proper plug for the unused gas line is advised.

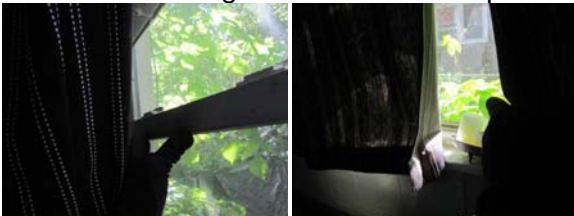
2. Screens missing at the left wall. Replacement/re-installation advised.

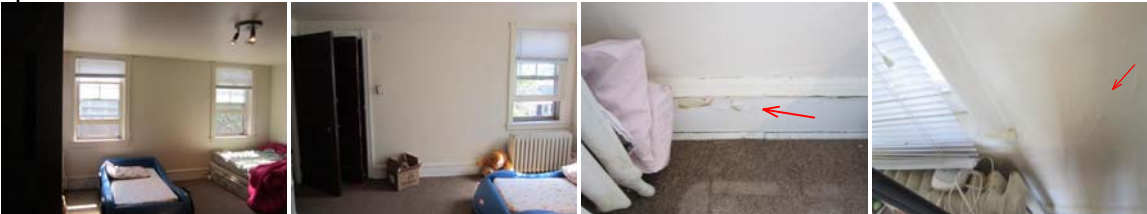
- Evidence of past or present water penetration at the rear left wall. Exterior water intrusion control and cosmetic repairs recommended.

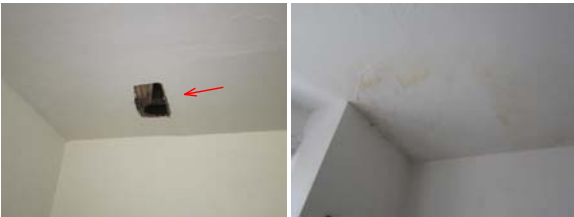
**74. 2nd Floor Front Bedroom Ceiling:** Painted wallboard/plaster-  
1. Cut out opening in the ceiling noted. Ceiling patching and repairs recommended.

2. Evidence of past or present water leakage at the front, roof evaluation/repairs and cosmetic repairs recommended.

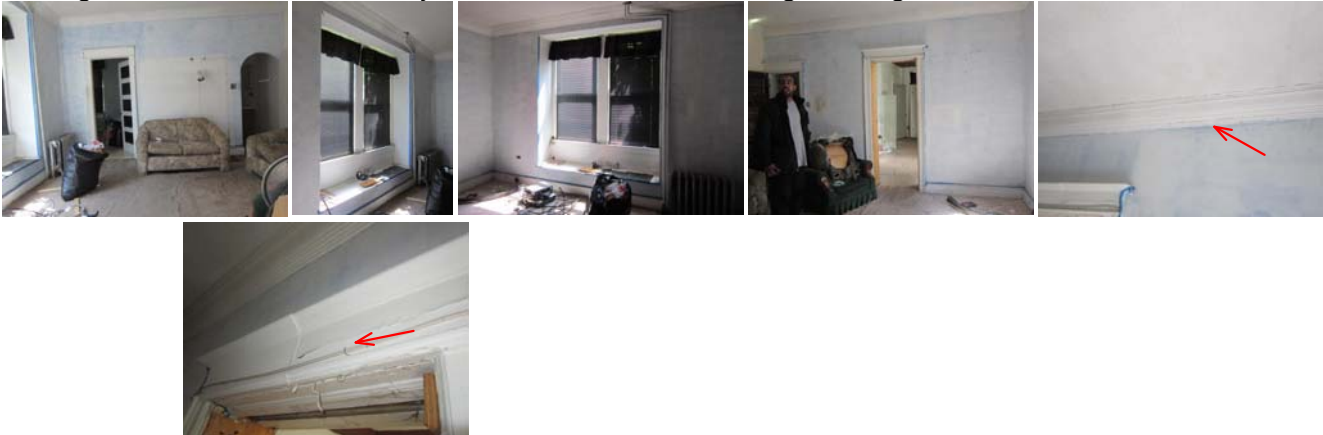
- 79. 1st Floor Bedroom Walls:** Painted wallboard-  
Evidence of previous leaks at the entry opening and peeling paint noted at the wood trim. Scraping and painting recommended. Paint may contain lead. Protection against ingestion/inhalation advised.

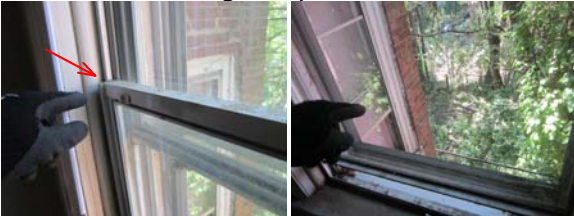
2. Screens missing. Replacement/re-installation prior to settlement advised.

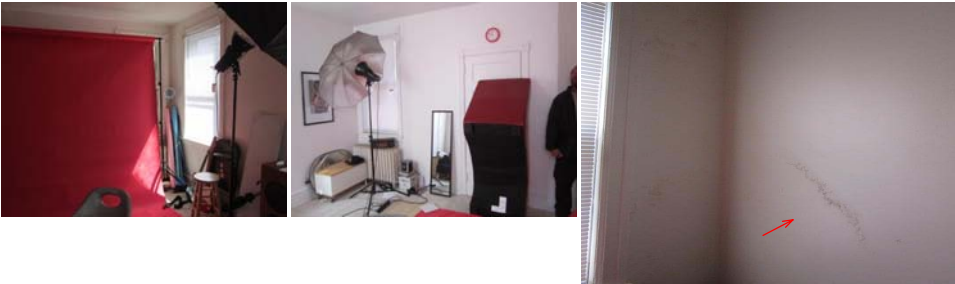
- 92. 2nd Floor Living Room Living Space Walls:** Painted wallboard/plaster-  
Evidence of past or present water penetration, exterior repairs/maintenance and cosmetic repairs recommended.

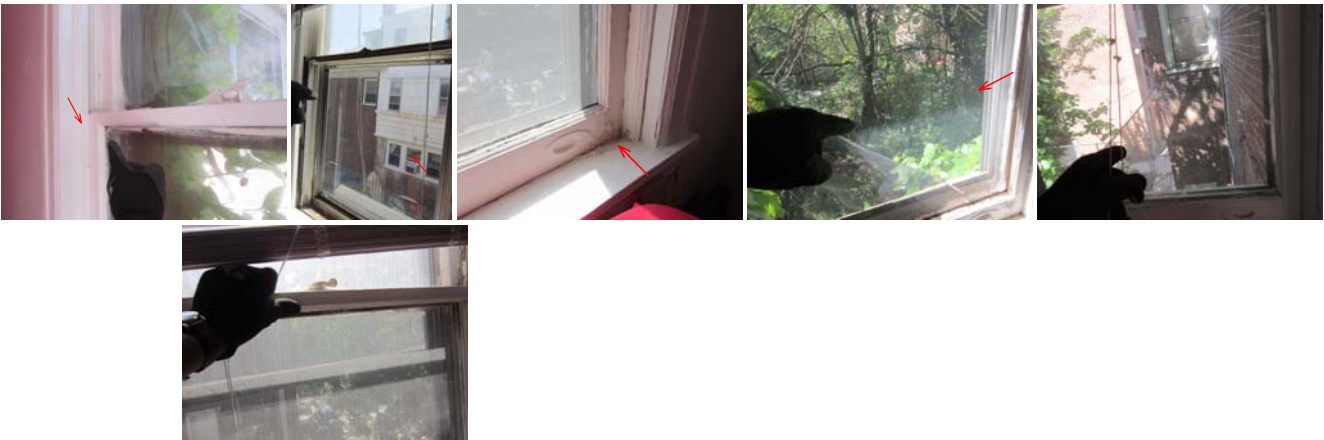
1. Missing/removed sash at the unit located at the left front region. Window repair/replacement needed.
2. Units at the left/right walls couldn't open when tested. Unit appears painted shut. Evaluation/repair or window adjustment recommended.
3. Screen damage/missing noted at the left/right wall units. Repair/replacement recommended.
4. Evidence of water/moisture at the left rear unit. Water penetration control needed.

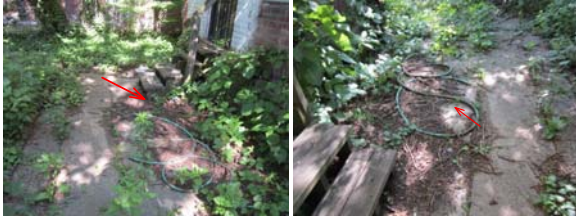
Grading improvement around the home's foundation is recommended to improve drainage and minimize water penetration in the basement.

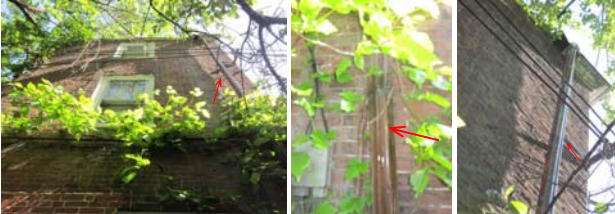
- 12. Downspouts:** Galvanized- Corroded and leaking rear downspout noted. Unit replacement recommended.
