## 2 – Family Building Inspection Report

**94 Silver Street  
New Britain, CT 06053**

Inspection Date: **11-19-13**

### **Inside & Out Home Inspection**

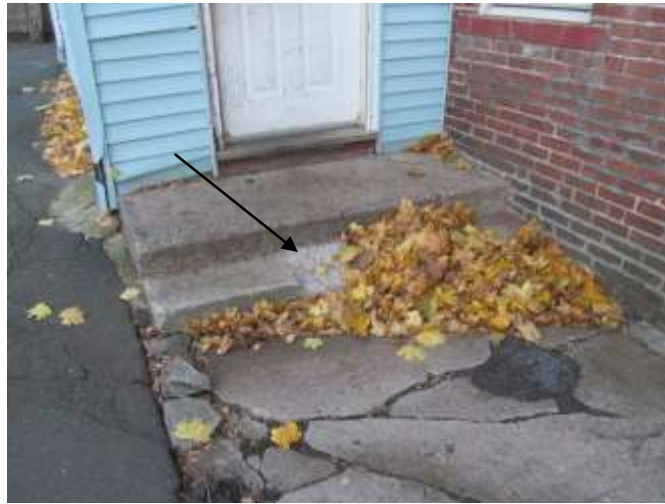
1. The lower step at the rear entry is broken. This is a fall hazard.

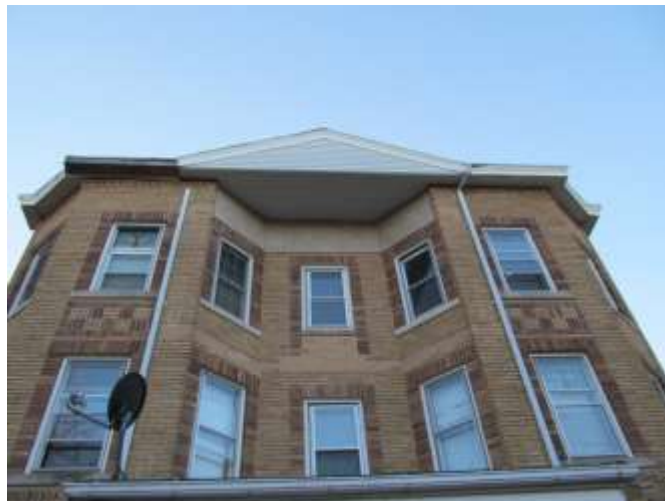
2. Soffit trim is missing on the left-front and right-front corner of the building.

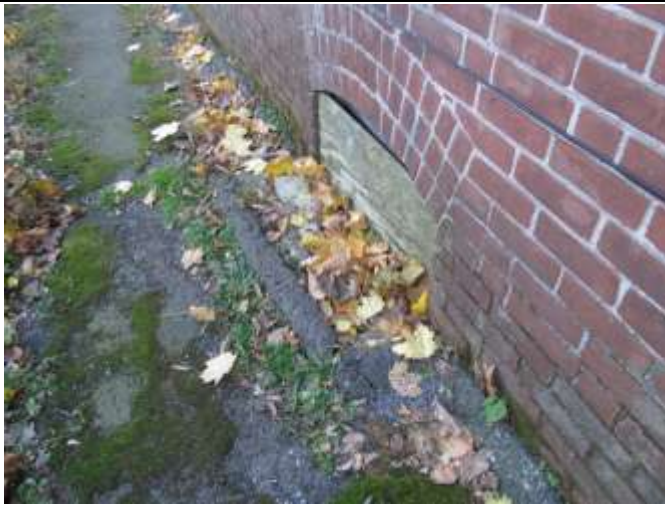
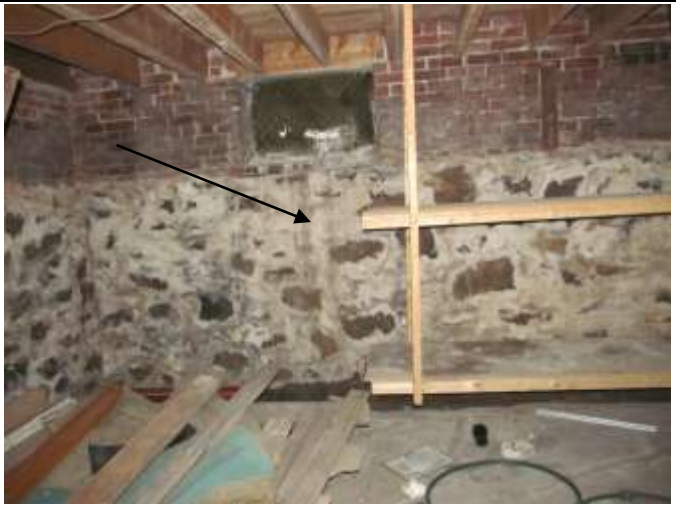
3. Most window screens are missing. Some screens are present in the basement. Replacement screens are available from this company: <http://www.screenitagain.com/home.aspx>
4. Some brick mortar is missing. Keep mortar maintained to prevent further deterioration.
5. Several windows in the rear entry stairwell are in poor condition.
6. Vinyl siding on the rear entry is loose in several areas. Trim is damaged on the left side.
7. **Water runs into the basement through the 2 right-rear basement windows.**

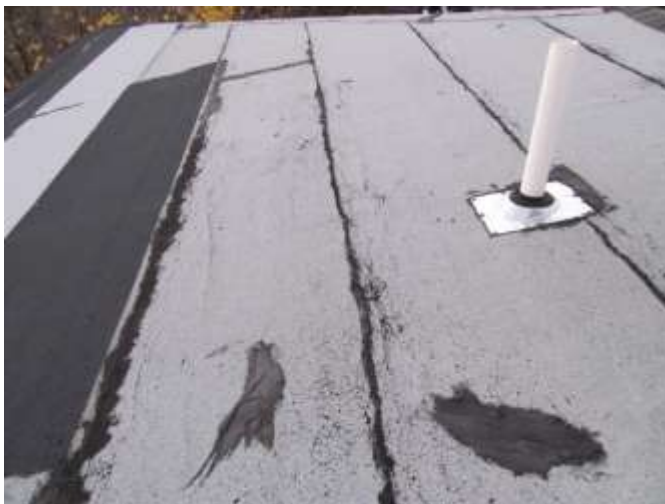
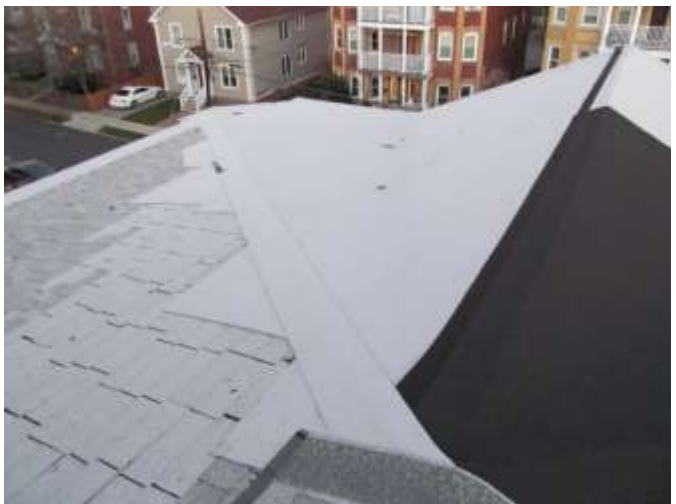
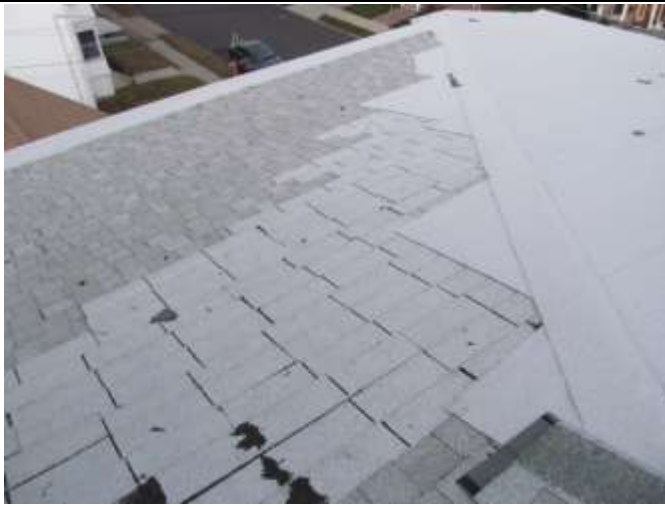
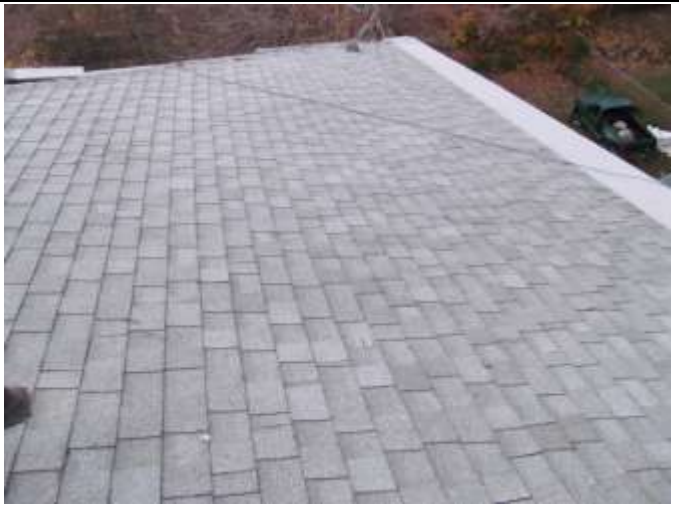
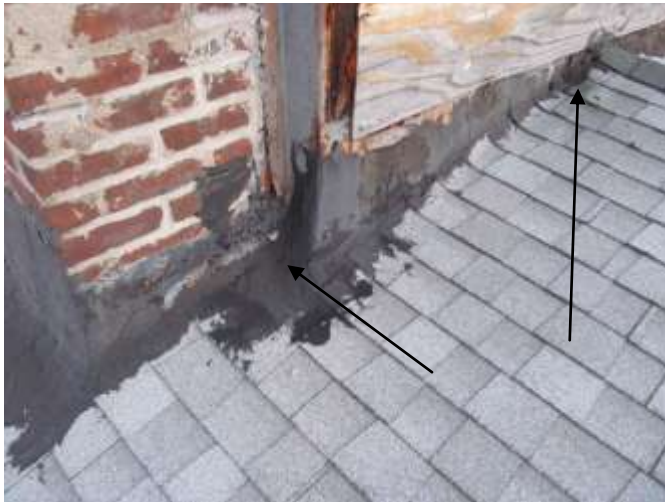
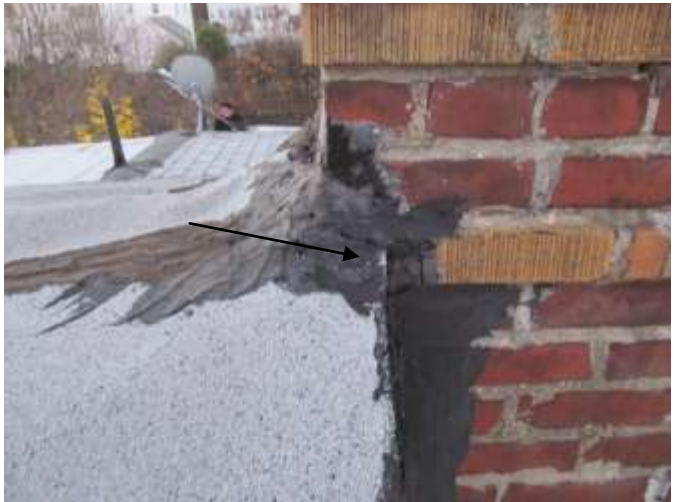
1. The roof appeared in fair condition. It has been repaired along the front and left edge. Repairs appeared adequate to repair previous deficiencies in the roof. The right side has been covered with architectural and triple-tab shingles. Other portions are granule covered asphalt roll roofing that is older. Black areas are visible where granules have released. The roof has been heavily patched. Gaps are present in roof cement on the small peak roof between chimneys that may be leak paths. These leaks would probably leak into the center chase of the building. There are 2 holes over the portion of the roof over the rear entry stairwell. These could be possible leaks. The roof's remaining life expectancy cannot be determined. Due to its age, leaks can occur at any time through the roof or any flashing. Leaks into the interior of the building can occur in winter weather from ice damming and damage ceilings and walls.

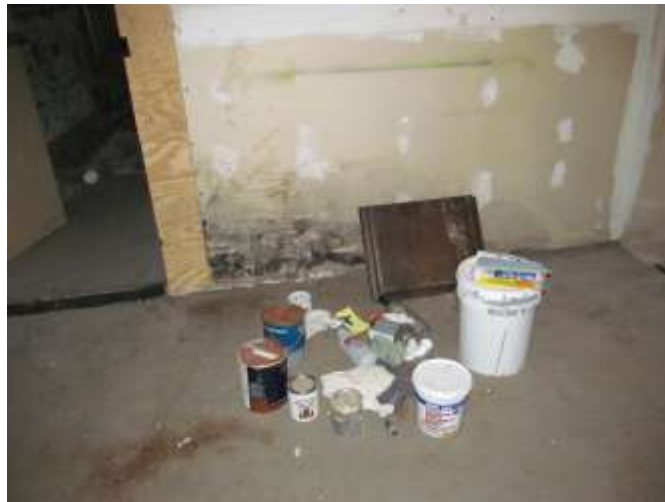
1. **Mold is present on the sheetrock wall in the left-front of the basement. If you are concerned about mold or the possible presence of mold in this building you should have an inspection conducted by a Certified Mold Remediation Company.**

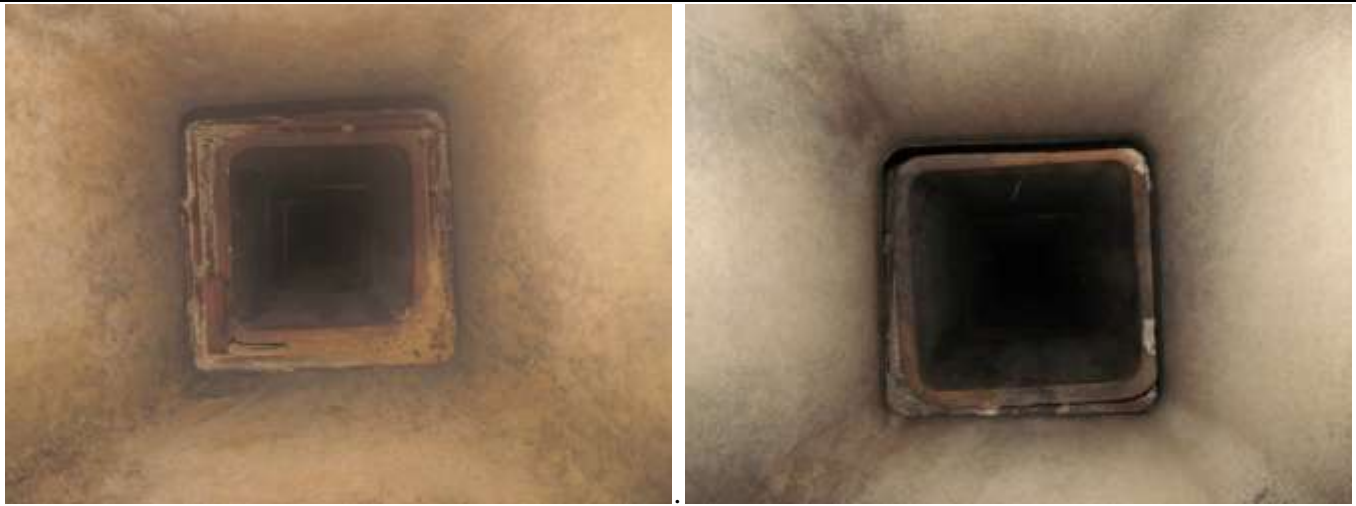
Conditin of chimney flues

1. Visible portions of chimneys appeared in acceptable condition.
2. Rain caps are not installed on chimneys. Water enters chimney structures and flues and deteriorates chimney mortar and the flue liners. This is accelerated by acid in flue gases combining with moisture. Debris can also enter the chimney and plug their bases. We recommend installing rain caps on chimneys. \*

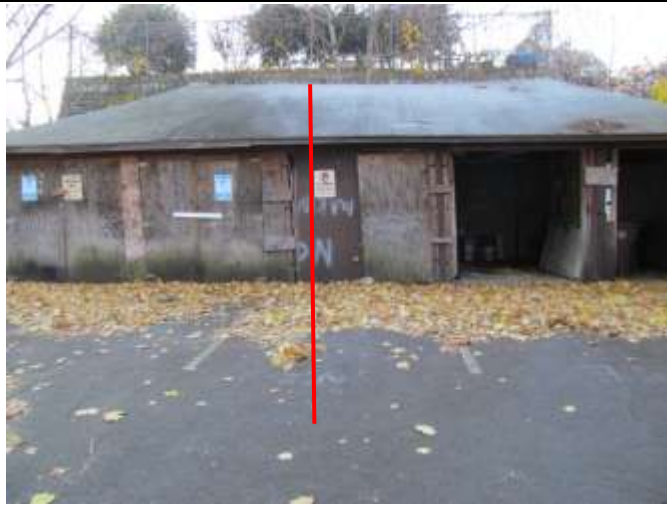
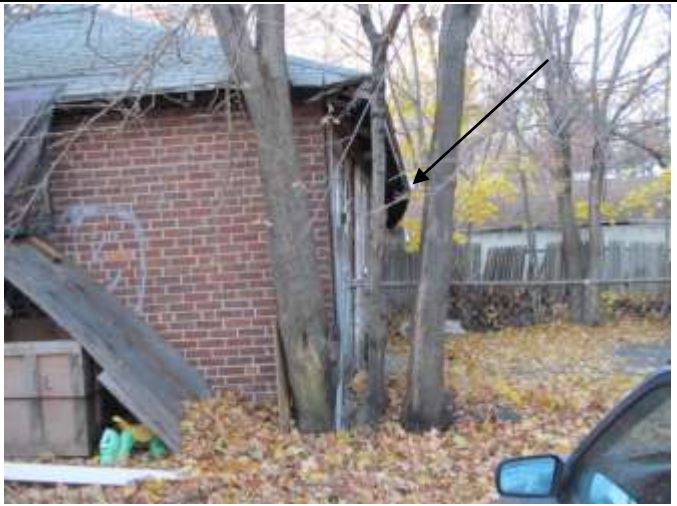
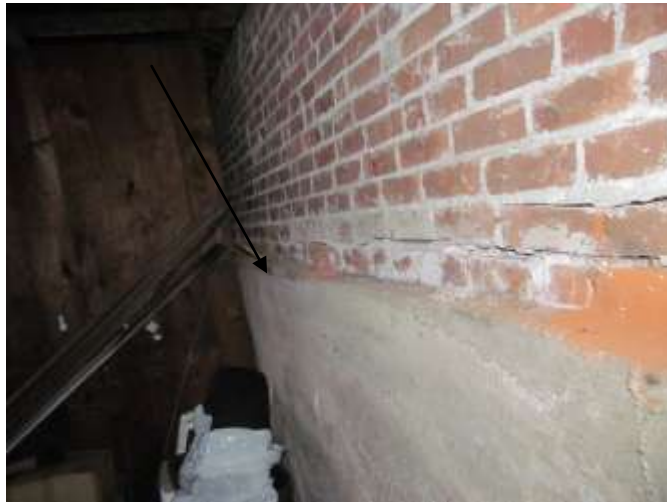
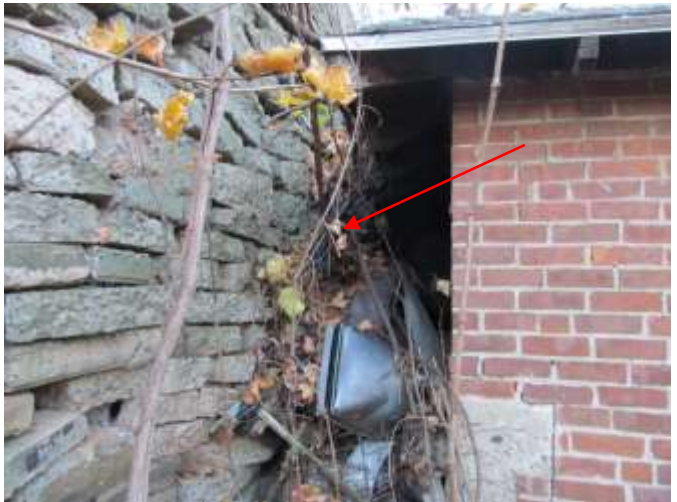
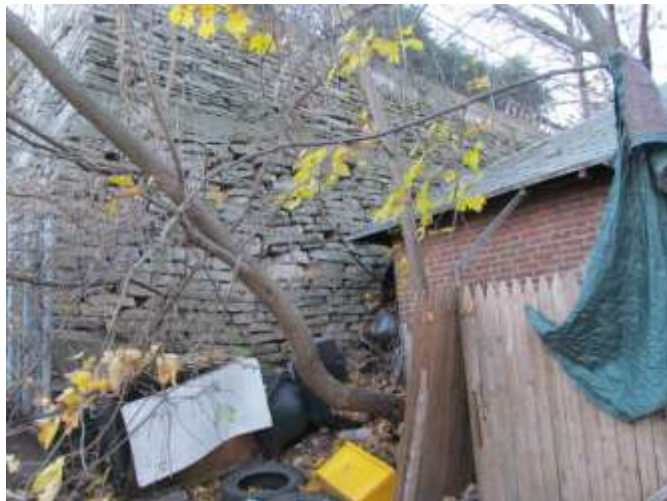
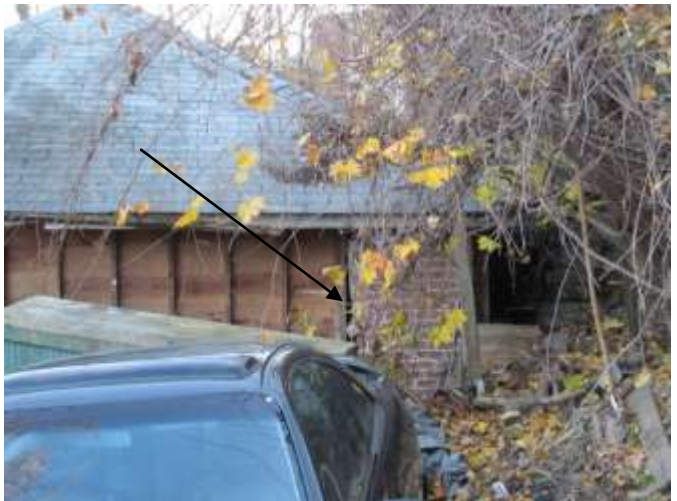
1. **The garage is in poor condition. The retaining wall on adjoining property at the rear has shifted forward causing the rear wall of the garage to move inward. This has caused the center of the garage to move forward approximately 8". The garage visibly leans to the left and the right end is also visibly pitched forward. It does not appear practical to repair the garage. The possibility exists that the retaining wall at the rear may fail under a period of heavy rain for an extended period of time. It may eventually fail from gradual soil pressure behind the wall.**
