**05/11/12 INSPECTION REPORT FOR:  
1336 W. 65TH AVE., PHILADLEPHIA, PA 19126**

TO: John Robinson  
RE: 1336 W. 65th Ave.,  
Philadelphia, PA 19126

At your request, a home inspection of the above property was performed on 05/11/12. **Armored Home Inspections, LLC** is pleased to submit the enclosed report. This report is a professional opinion based on a visual inspection of the accessible components of the building.

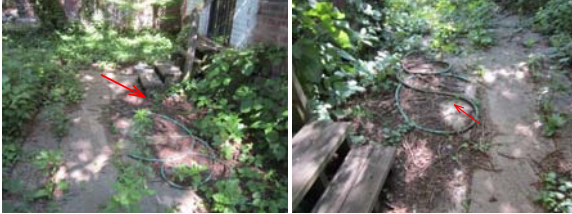
Grading improvement around the home's foundation is recommended to improve drainage and minimize water penetration in the basement.

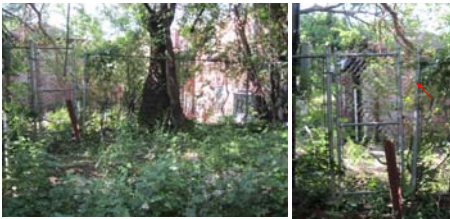
#### Fences: Chain Link-

The gate at the rear yard noted locked with chain but detached. Fencing repairs/maintenance advised.

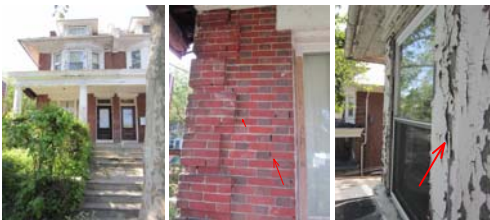
1.Mortar loss evident in exterior porch wall. Pointing/wall maintenance to prevent further mortar loss and possible water infiltration is recommended.

2.Heavy peeling paint noted at the upper floor bay area. Scraping and painting recommended. The paint may contain lead. A contractor with certification in Lead Safe Work Practices is recommended.

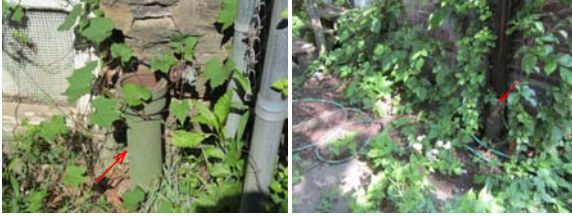
Corroded and leaking rear downspout noted. Unit replacement recommended.

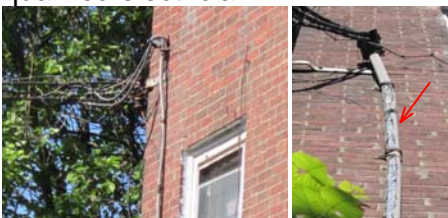
#### Service: Aerial-

Frayed service wire covering with ground wire exposure visible, replacement recommended by a qualified electrician.

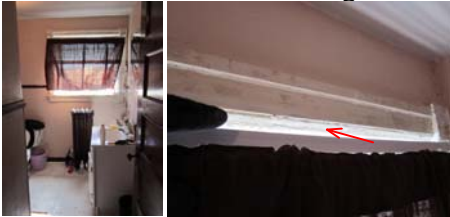
**Walls:** Painted wallboard, Paneling-

Peeling paint noted at the window trim noted. Scraping and painting recommended. Paint may contain lead. Protection against ingestion/inhalation advised.

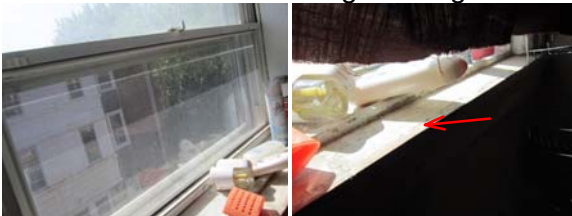
**Windows:** Aluminum double hung-

Peeling paint observed at the window sill. Scraping and painting recommended. Paint may contain lead. Protection against ingestion/inhalation advised.

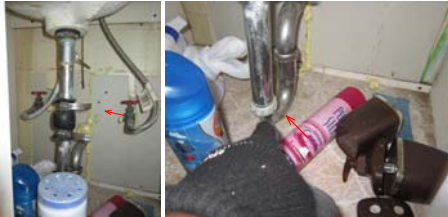
**Faucets/Traps:** Brand unknown-  
Leak in drain line observed. Plumber repair is recommended.

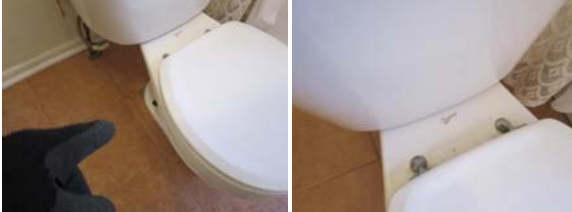
**Toilets:** Mansfield-

The toilet is loose at the floor, plumber evaluation and repair advised. Wax ring installation may also be necessary.

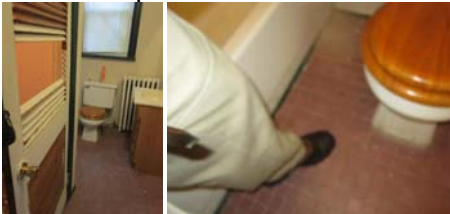
**Floor:** Ceramic tile-

Movement in the tile floor indicate poor tile adhesion and limited service life remaining. Budgeting for floor repairs recommended.

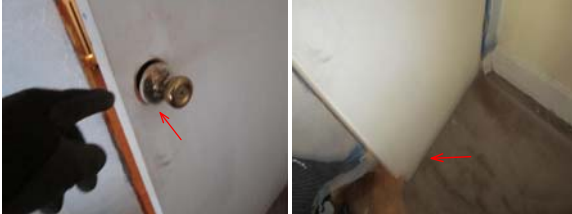
**Doors:** Hollow core-

1. Loose hardware observed, securing hardware recommended.
2. Door rubs at floor. Recommend door adjustment to prevent rubbing at floor.

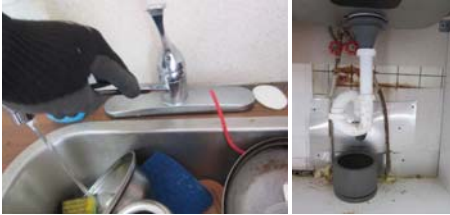
**Plumbing/Fixtures:** Brand unknown-

Loose faucet noted. Securing the faucet is recommended.

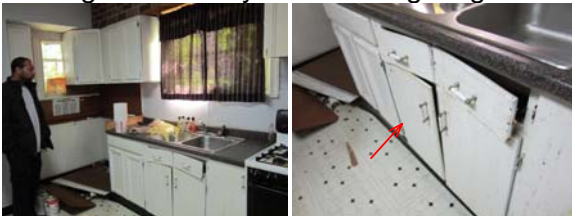
**Cabinets:** Wood-  
Damaged cabinetry noted. Budgeting for new cabinetry is advised.

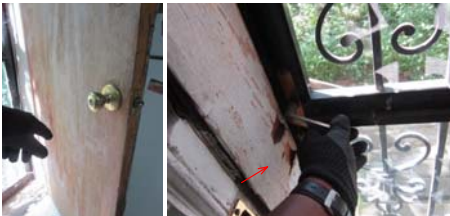
38. Acceptable **Floor:** Vinyl floor covering  
39. Marginal **Doors:** Solid wood-  
1. Rear entry door is in disrepair, repairs recommended to prolong door service life.

2. Peeling paint noted at the door jamb. This paint may contain lead. A lead test before disturbing advised.

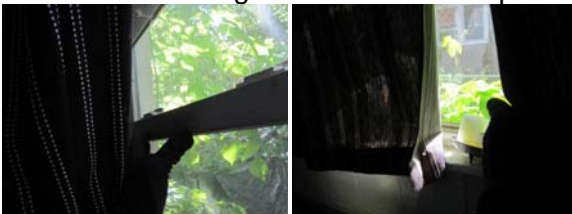
40. Marginal **Windows:** Vinyl double hung-  
1. Unit couldn't open at rear wall when tested. Unit appears painted shut. Evaluation/repair or window adjustment recommended.

2. Screens missing at the left wall. Replacement/re-installation advised.

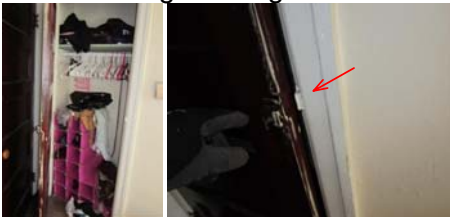
**Closet:** Standard-

1. Door can not close in jamb, repair/adjustment recommended.
2. Peeling paint noted in closet. Scraping and painting recommended. Paint may contain lead. Protection against ingestion/inhalation advised.

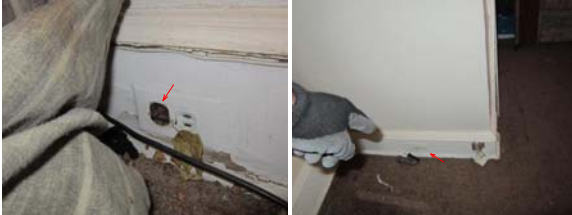
1.Damaged receptacle at the rear wall noted. Unit replacement for safety advised.

2. Older two prong receptacles noted, consider electrical upgrades.

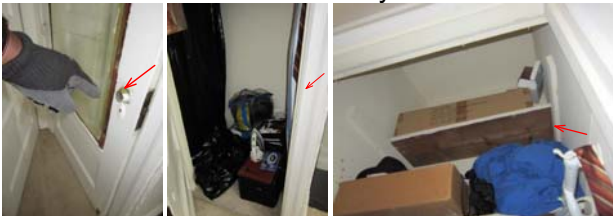
1.Door hardware missing, replacement recommended.

2.Stored items limited visibility.

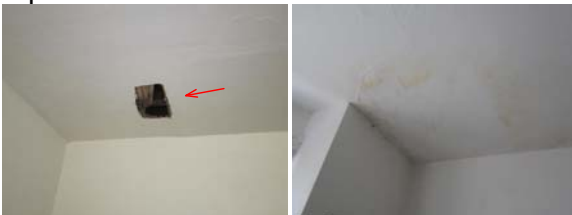
**Ceiling:** Painted wallboard/plaster-

1.Cut out opening in the ceiling noted. Ceiling patching and repairs recommended.

2. Evidence of past or present water leakage at the front, roof evaluation/repairs and cosmetic repairs recommended.

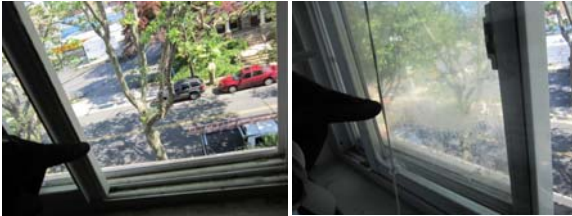
1. Screens missing. Replacement/re-installation prior to settlement advised.

2. Moisture between panes of glass indicate defective thermal seal. Window repairs/replacement recommended.

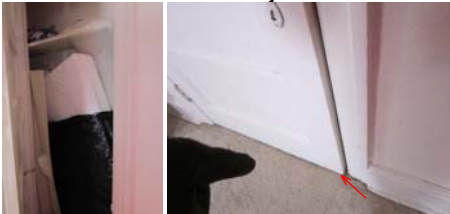
**Closet:** Standard-

Door rubs at floor adjustment/trimming recommended.

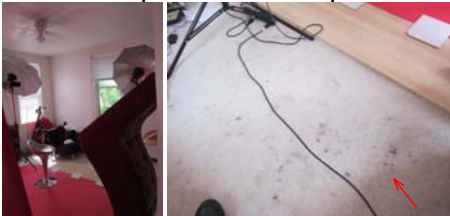
**Floor:** Carpet- Soiled carpet noted. Cleaning carpet recommended.

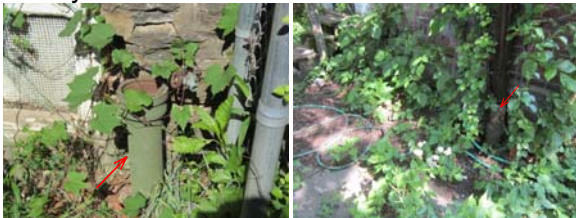
**2. Leader/Extension: Underground-**

Underground drains cannot be judged. Consider plumber evaluation as underground drains are not within the scope of this inspection. Rating reflects visible components. Checking underground drains for backing up during heavy rains advised.

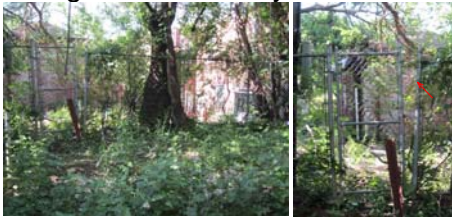
### 3. Fences: Chain Link-

The gate at the rear yard noted locked with chain but detached. Fencing repairs/maintenance advised.

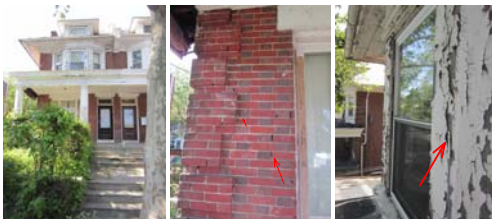
1.Mortar loss evident in exterior porch wall. Pointing/wall maintenance to prevent further mortar loss and possible water infiltration is recommended.

2.Heavy peeling paint noted at the upper floor bay area. Scraping and painting recommended. The paint may contain lead. A contractor with certification in Lead Safe Work Practices is recommended.

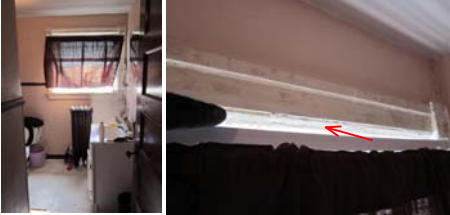
- 31. 3rd Floor Bathroom Walls:** Painted wallboard, Paneling-  
Peeling paint noted at the window trim noted. Scraping and painting recommended. Paint may contain lead.  
Protection against ingestion/inhalation advised.

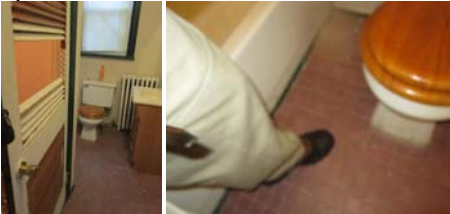
- 45. 1st Floor Bathroom Floor:** Ceramic tile-  
Movement in the tile floor indicate poor tile adhesion and limited service life remaining. Budgeting for floor repairs recommended.

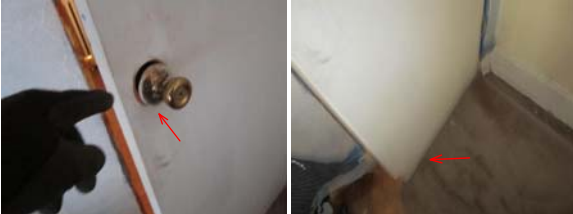
- 46. 1st Floor Bathroom Doors:** Hollow core-  
1. Loose hardware observed, securing hardware recommended.  
2. Door rubs at floor. Recommend door adjustment to prevent rubbing at floor.

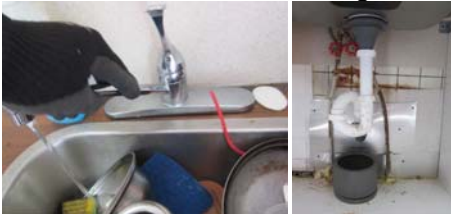
Loose faucet noted. Securing the faucet is recommended.

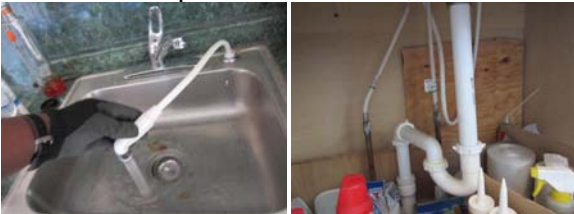
- 58. 2nd Floor Kitchen Plumbing/Fixtures:** Brand unknown-  
Hot and cold operation reversed, recommended faucet line correction by a qualified plumber

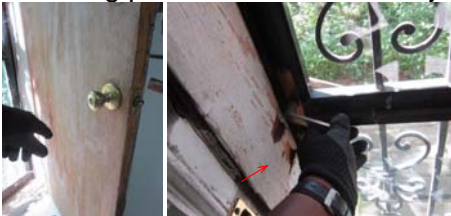
1. Rear entry door is in disrepair, repairs recommended to prolong door service life.

2. Peeling paint noted at the door jamb. This paint may contain lead. A lead test before disturbing advised.

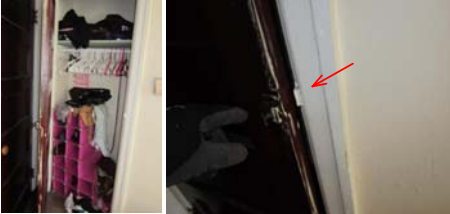
1. Door can not close in jamb, repair/adjustment recommended.
2. Peeling paint noted in closet. Scraping and painting recommended. Paint may contain lead. Protection against ingestion/inhalation advised.

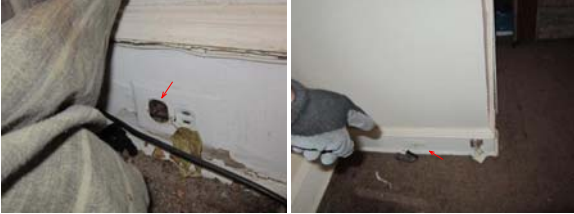
1. Damaged receptacle at the rear wall noted. Unit replacement for safety advised.
2. Older two prong receptacles noted, consider electrical upgrades.

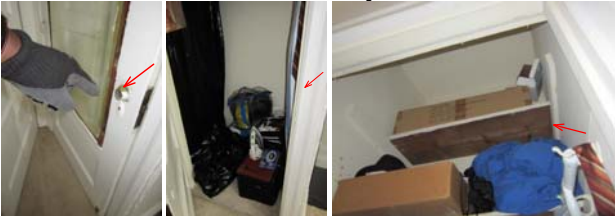
**73. 2nd Floor Front Bedroom Closet:** Standard-  
1. Door hardware missing, replacement recommended.

2. Stored items limited visibility.

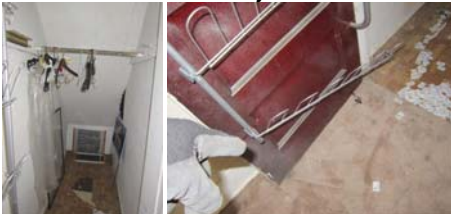
- 78. 1st Floor Bedroom Closet:** Walk In-  
Door rubs at floor adjustment/trimming recommended.

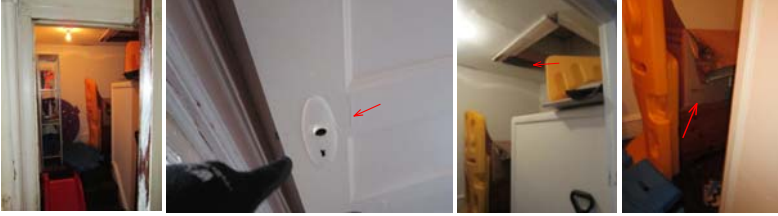
- 82. 3rd Floor Unit Hallway Living Space Closet:** Walk In-  
1. Door hardware missing, replacement recommended.
2. Leak at the ceiling hatch noted. This is indicating a roof leak. Roof evaluation and repairs advised.

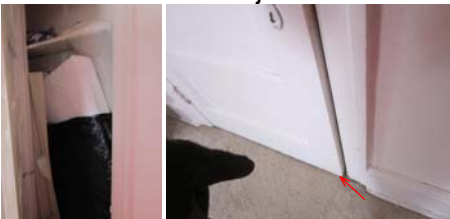
- 91. 2nd Floor Living Room Living Space Closet:** Standard-  
Door rubs at floor adjustment/trimming recommended.

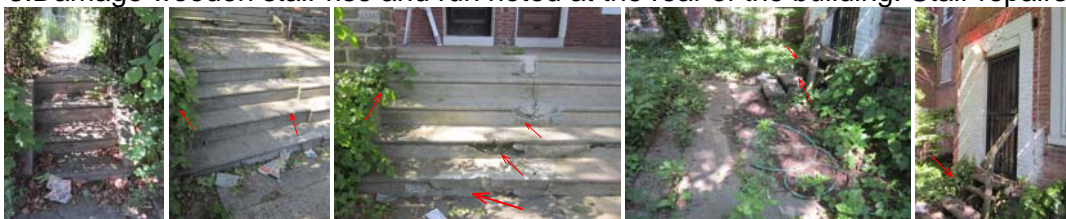
1. Railing missing at the three sets of front stairs. Railings are recommended when three or more risers are present in the stair construction.
2. Stair damage/deterioration noted at the front entry. Stair repairs recommended for occupant safety.
3. Damage wooden stair rise and run noted at the rear of the building. Stair repairs/replacement recommended.

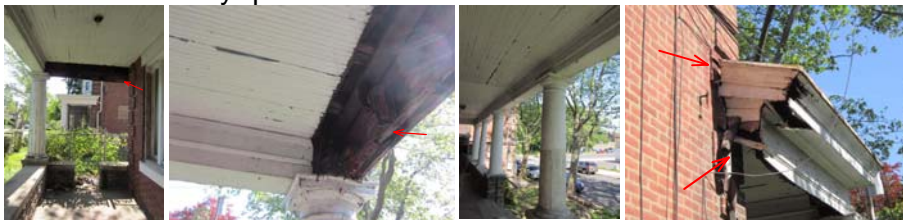
#### 2. Porch: Concrete- 1. Damaged left end roof rake end and wood framing noted. Area repairs by a qualified contractor is advised.

2. Deferred wood trim and ceiling maintenance noted through out. Porch exterior maintenance and repairs recommended by qualified contractors.

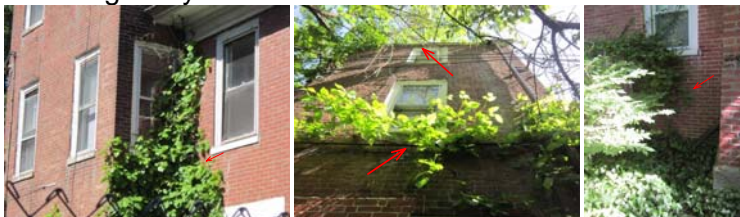
1. Overgrown vegetation noted around the structure and vine growth upon the structure. Cutting back vegetation away from the building and removing the vine growth from the building is recommended.
2. Tree limbs close to the structure and may be causing damage to the roof or structure at the rear. Tree limb trimming away from the structure 5'-10' recommended.

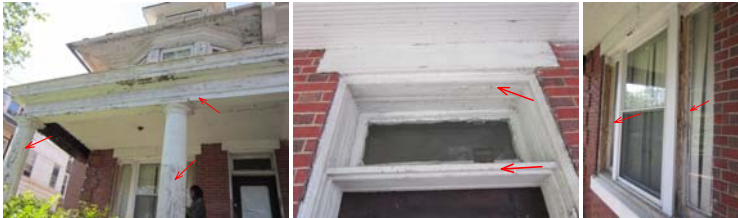
1. Wood trim at the front porch columns, wood beam cover, window trim, and entry door trim noted with significant peeling paint and deferred maintenance.

2. Left end of the porch with wood rot and significant damage. Area evaluation and a quote for repairs recommended.

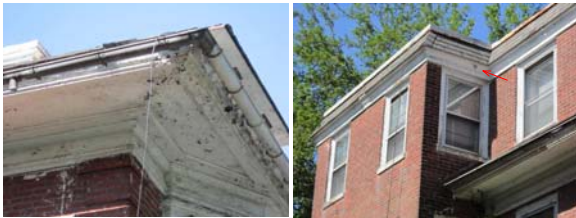
Peeling paint noted throughout the fascias. Fascia scraping and painting/maintenance recommended to prevent further deterioration.

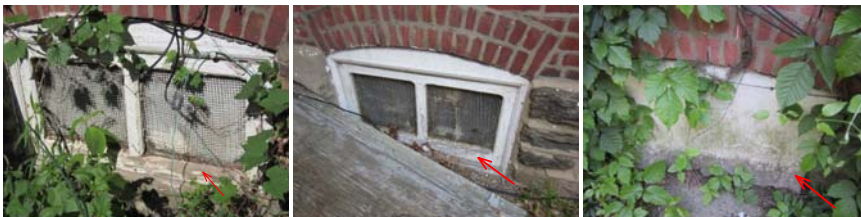
Only window screens were visible from the exterior. Deferred maintenance noted at the wood framed screens. Screen and trim maintenance to prevent wood decay is advised. Budgeting for window unit replacements advised.

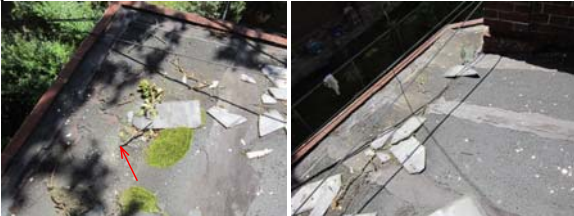
- 11. Porch Roof Surface Material:** Rolled roof material- Roof shows signs of deterioration, roof evaluation and estimate for repair/replacement recommended by a qualified roofer.

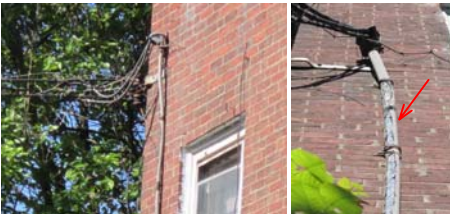
- 14. Service:** Aerial- Frayed service wire covering with ground wire exposure visible, replacement recommended by a qualified electrician.

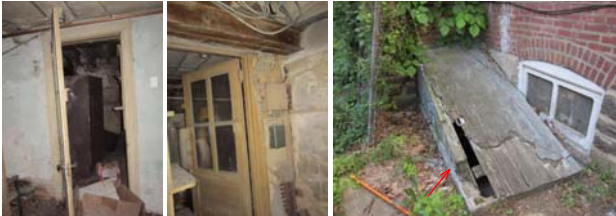
1. The interior door noted within the basement was not tested. Visual inspection revealed no deficiencies.
2. The walk out hatch door is deteriorated and in need of replacement.

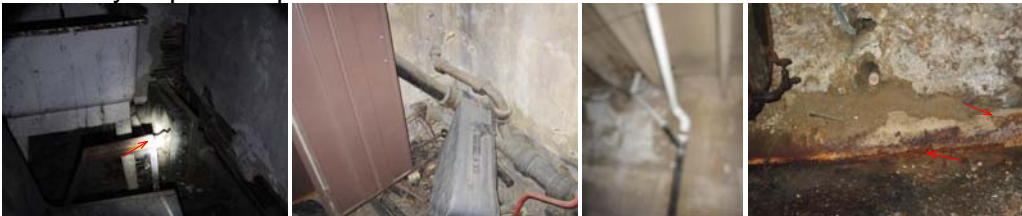
- 22. Drain Pipes:** Cast iron, PVC-
1. Detached piping in the area of the laundry tub located in the rear region of the basement. Piping evaluation and repairs to prevent sewer gases from entering the basement is advised.
  2. Corroded cast iron piping at the floor level noted at the basement front. Piping evaluation and replacement as needed by a qualified plumber is recommended.

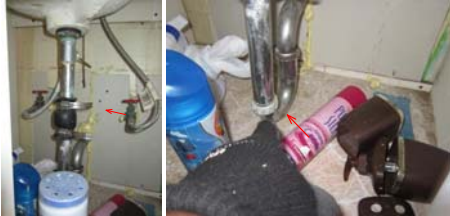
- 26. 3rd Floor Bathroom Faucets/Traps:** Brand unknown-  
Leak in drain line observed. Plumber repair is recommended.

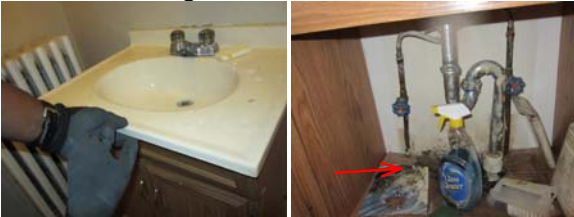
- 27. 1st Floor Bathroom Counter/Cabinet:** Molded bowl and cabinet-  
1. Counter top/sink not properly mounted to cabinet, securing recommended by a qualified professional.  
2. Water damage noted at the base of the cabinet. Cabinet/vanity replacement recommended.

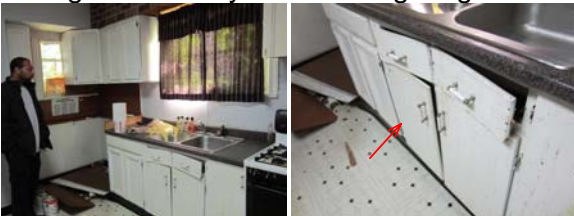
- 29. 1st Floor Kitchen Cabinets:** Wood-  
Damaged cabinetry noted. Budgeting for new cabinetry is advised.

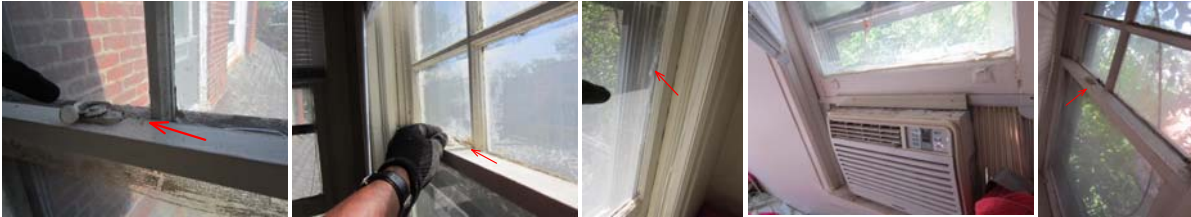
Windows couldn't lock and deteriorated glazing observed. Budgeting or widow repairs or replacement recommended.

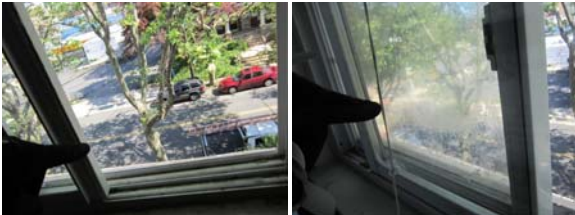
1. Screens missing. Replacement/re-installation prior to settlement advised.

2. Moisture between panes of glass indicate defective thermal seal. Window repairs/replacement recommended.

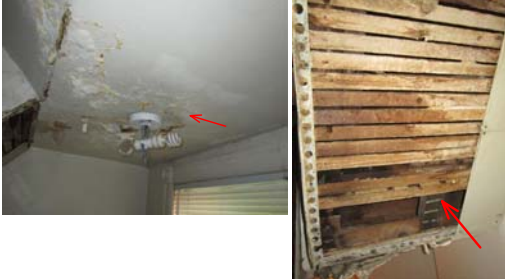
Water damaged ceiling noted. Ceiling repair/replacement needed.
